DEPARTMENT OF TRANSPORTATION**DIVISION OF ENGINEERING SERVICES**

Contract #: 04-0120F4Cty: SF/ALA Rte: 80 PM: 13.2/13.9File #: 69.28**WELDING INSPECTION REPORT****Resident Engineer:**Pursell, Gary**Address:** 333 Burma Road**City:** Oakland, CA 94607**Report No:** WIR-000321**Date Inspected:** 30-Jul-2007**Project Name:** SAS Superstructure**OSM Arrival Time:** 800**Prime Contractor:** American Bridge/Fluor Enterprises, a JV**OSM Departure Time:** 1630**Contractor:** Zhenhua Port Machinery Company, Ltd (ZPMC), Changxing Island **Location:** Shanghai, China**CWI Name:****CWI Present:****Yes No****Inspected CWI report:** **Yes No N/A****Rod Oven in Use:** **Yes No N/A****Electrode to specification:** **Yes No N/A****Weld Procedures Followed:** **Yes No N/A****Qualified Welders:** **Yes No N/A****Verified Joint Fit-up:** **Yes No N/A****Approved Drawings:** **Yes No N/A****Approved WPS:** **Yes No N/A****Delayed / Cancelled:** **Yes No N/A****Bridge No:** 34-0006**Component:** Tower Mock Up Assemblies-77M-89M-114M**Summary of Items Observed:**

Tower Shop -77 Meter Mock-Up Assembly Area

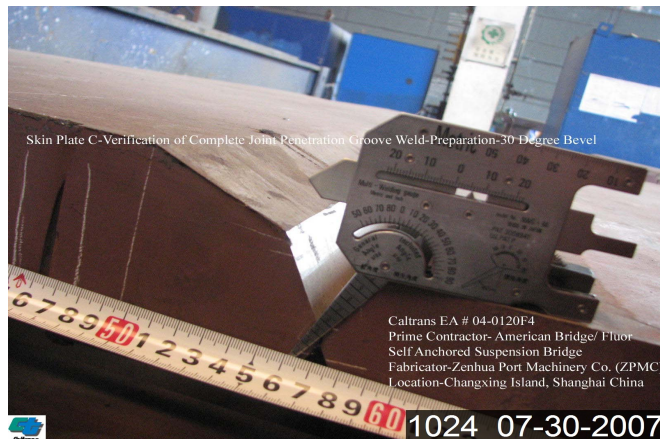
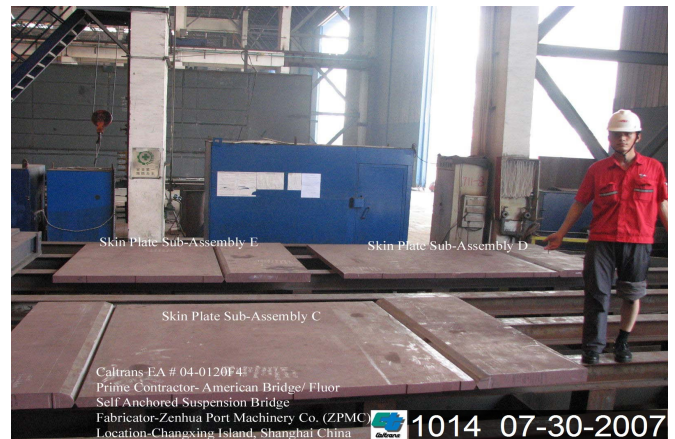
a) Skin plate-C- sub-assembly-this sub assembly consists of three (3) steel plates that will be joined with double vee complete joint penetration groove welds. There is a 90mm thick plate piece mark MP13 that will join to a 60mm thick plate piece mark MA4, 60mm thick plate piece mark MA4 will join to a 90mm thick plate identified as MP12. The Caltrans QA Inspector performed dimensional verification of the identified steel skin plates and recorded that the

width of plate MP13 is 570cm verses the drawing dimension of 560cm, MA4 has a width of 204cm verses the drawing of 207cm, MP12 was measured to have a width of 710.5cm verses the drawing width of 710cm. The measured double vee complete joint penetration groove angles reflected an included angle of sixty (60) degrees for both sides of the prepared joint splices.

b) Skin plate-E sub-assembly- this sub assembly consists of two (2) steel plates that will be joined with a double vee complete joint penetration groove weld. There is a 75mm thick plate piece mark MA1-1 that will join to a 100mm thick plate piece mark MP15. The Caltrans QA Inspector performed dimensional verification of the identified steel skin plates and recorded that the width of plate MA1-1 is 157 cm as identified on the drawing, MP15 has a width dimension of 83 cm verses the drawing measurement of 82cm. The measured double vee complete joint penetration groove angles reflected an included angle of sixty (60) degrees for both sides of the prepared joint splice.

c) Skin plate-D- sub-assembly- this sub assembly consists of two (2) steel plates that will be joined with a double vee complete joint penetration groove weld. There is a 60mm thick plate piece mark MUSA-MA5 that will join to a 90mm thick plate piece mark MP14. The Caltrans QA Inspector performed dimensional verification of the identified steel skin plates and recorded that the width of plate MA5 is 239cm verses the drawing dimension of 238cm, MP14 has a width of 75.5cm verses the drawing of 75cm. The measured double vee complete joint penetration groove angles reflected an included angle of sixty (60) degrees for both sides of the prepared joint splices.

The Caltrans QA Inspector observed that there are no ZPMC Quality Control distinguishing marks that identify dimensional verification of the identified plates or verification of the complete joint penetration groove angles. ZPMC also has not provided any records that identify the inspection of such items per the fabrication procedure. The Caltrans QA Inspector has observed minimal participation of ABF personnel monitoring the Caltrans Tower mock-up fabrication in progress. Included below are digital pictures of the observation of the identified skin plates which also include ZPMC representative Mr. Xu Jun (Eric).

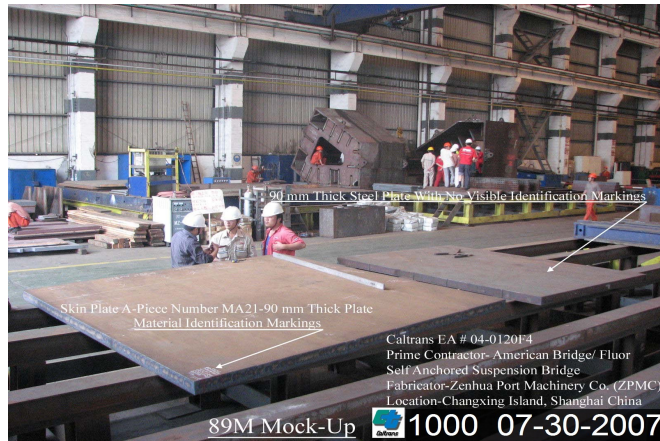
The Caltrans QA Inspector observed that ZPMC has positioned two skin plate sub-assemblies on elevated steel supports. One of the 90 mm thick skin plates is identified for use as Skin Plate A with a piece number MA21. The second skin plate is positioned where the identification markings are not accessible. Included below is a digital picture of the observed two 90mm steel plates.

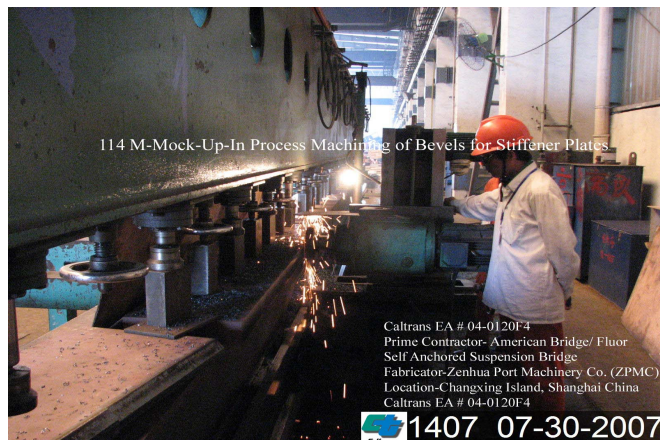
The Caltrans QA Inspector observed that ZPMC is continuing with the machining of bevels on numerous stiffener plates. Several of the 70 mm thick steel plates were identified as piece numbers PP20-7, PP20-8 and MP1008-1. Included below is a digital picture of this observation.

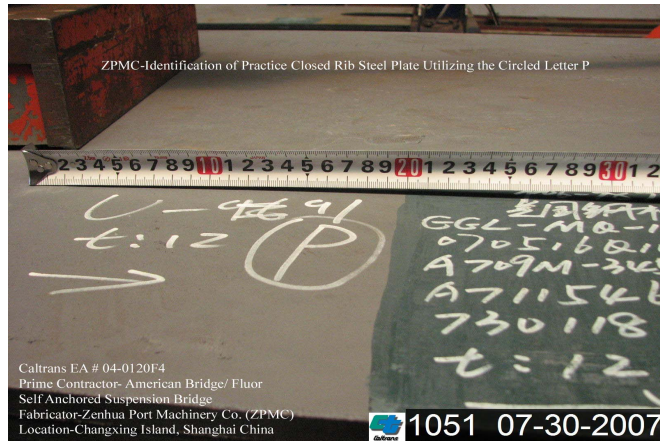
2) Closed Rib beveling- The Caltrans QA Inspector observed that there are approximately fourteen (14) ZPMC workers that are participating in the beveling of two closed ribs identified as piece numbers V-72 and V-75. The Caltrans QA Inspector questioned the ZPMC Representative Mr. Xu Jun (Eric) as to whether or not the beveling of the closed ribs is for purposes of practice or actual trial closed ribs since the observed closed ribs contain the ZPMC number of ZP06-787, which represents the Caltrans project. Mr. Xu Jun voiced that these two closed ribs are scheduled for use for the Caltrans closed rib trials. It was not clear if these closed ribs were to be used for welding purposes or for purposes of demonstrating ZPMC's press forming operation for the closed ribs. Mr. Xu Jun voiced that ZPMC utilizes a circled alpha letter P to indicate that such components are for practice purposes only. Included below is a digital picture of the circled letter P on a closed rib identified as V-91 that was being beveled.
